Overcoming Challenges While Rehabilitating a Corroded Aerial Sewer in a Tidal Marsh

Wayne Miles, PE, CDM
Frank Styers, PE, Cape Fear Public Utility Authority
Chris Bowling, PE, Cape Fear Public Utility Authority
Christine Nesbit, PE, CDM
Michael Sloop, PE, CDM

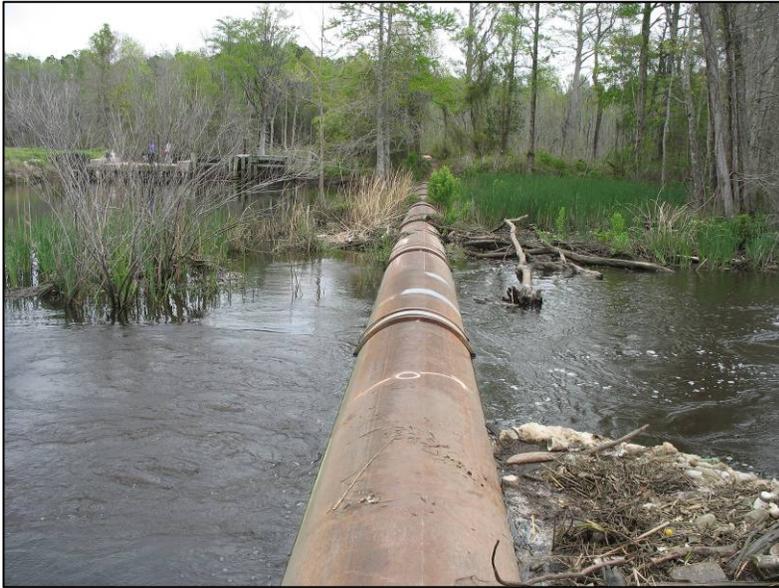
Figure 3 – View of Pipe and Retaining Straps Looking from Junction Box #2 to Manhole #1

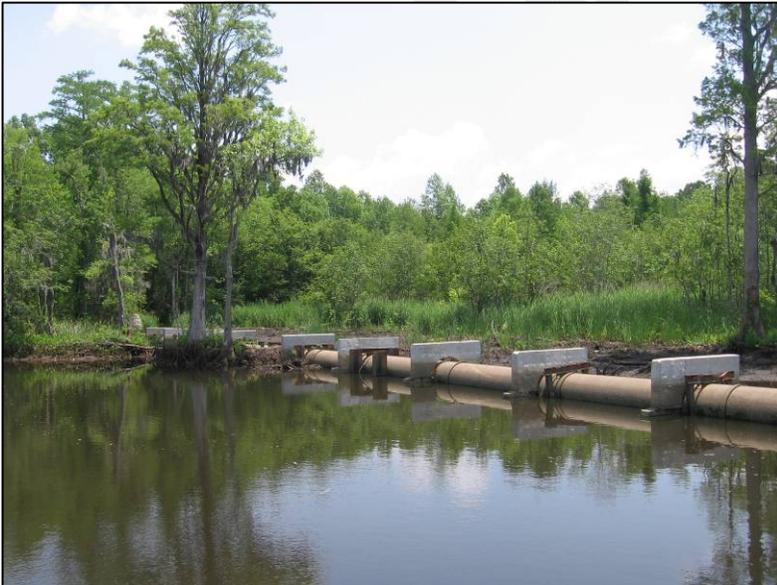
Figure 4 – View of Pipe and Concrete Piers Looking Downstream (Low Tide)

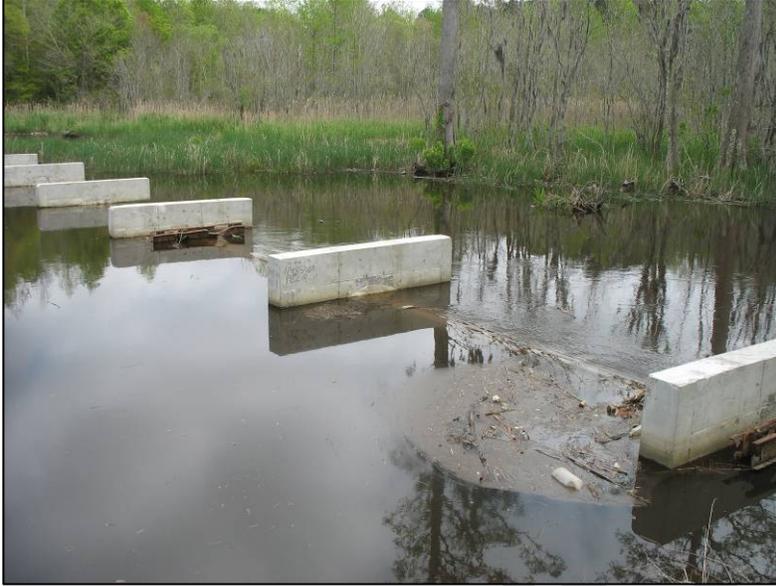
Figure 5 – View of Pipe and Concrete Piers Looking Downstream (High Tide)

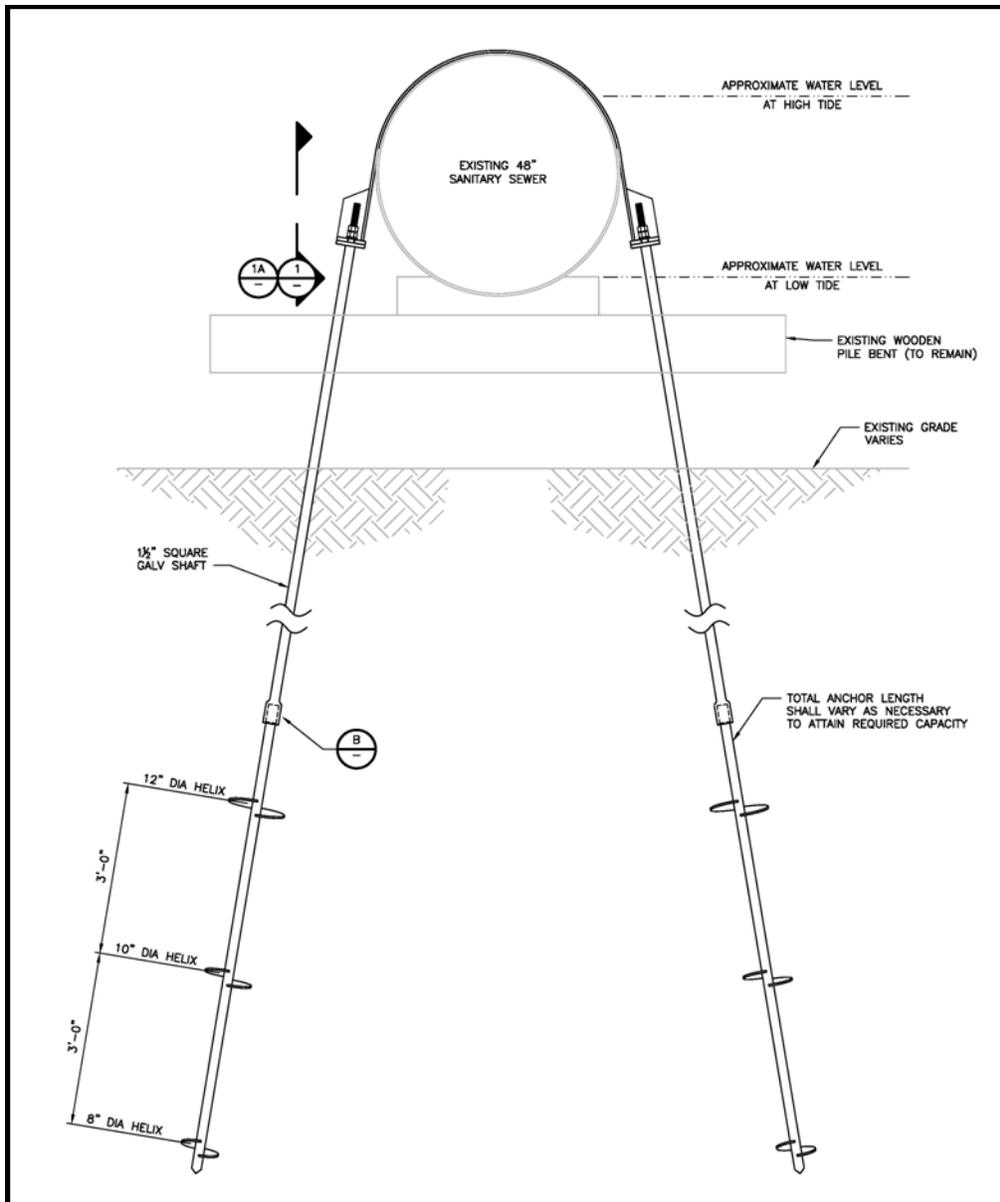
It was anticipated that pipe buoyancy would increase upon removal of the sediment in the pipe. Therefore, the helical anchor design was reviewed during the design of the pipeline rehabilitation. New anchors had been installed only three years previously as part of a previous pier improvements project, and the design was consistent with current design needs. Despite this review, however, the anchors failed upon removal of the sediment. As a result, the pipeline began to float during high tide conditions. This was a result of the anchors not being fully embedded in a hard sediment layer, thus preventing the anchors from being installed to the required depth as designed (see design detail in Figure 6).

Figure 6 – Helical Anchors Installed Three Years Prior Failed Upon Removal of Sediment in the Pipe. New Anchors with a Thicker Shaft and Smaller, Sharpened Helices Achieved the Required Installation Depth.

The anchor failure created the need for an emergency helical anchor design and construction project in a difficult-to-access project location. The pipe was kept filled with water to avoid it from floating during anchor repair.

In the new installation, the anchor shaft thickness was increased and the diameter of the helices was reduced to ease penetration into the hard sediment layer. In addition, the helical edges were sharpened to improve penetration into the hard layer (see Figure 7). This resulted in anchor installation to the required depth as designed.

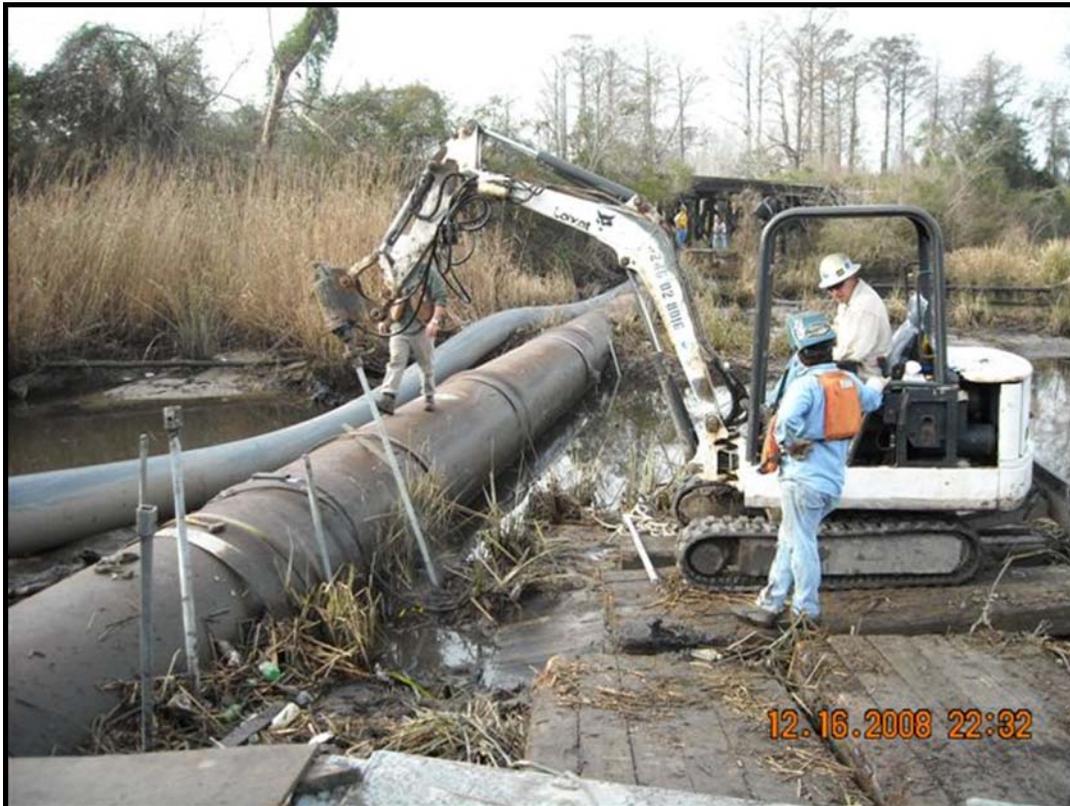
Figure 7 – New Helical Anchors Were Installed on an Emergency Basis – Thicker Shaft Anchors and Increased Installation Torque Penetrated a Hard Sediment Layer to Install Anchors to the Required Depth
