As much as 7 in. (178 mm) of concrete in the roof of the old box conduit at the Metro Wastewater Reclamation District South Plant had corroded away from the original 14-in. (356-m) roof thickness leaving the lower rebar reinforcing mat visible in places.

The 12-ft by 9-ft (3.7-m by 2.7-m) box conduit was put in service in the Metro Wastewater Reclamation District (Metro; Denver) South Plant in 1976 to carry primary effluent from four 150-ftdiameter (45.7-m-diameter) primary clarifiers to eight nearby aeration basins and 10 secondary clarifiers. As operated in 2005, the conduit was conveying as much as 144 mgd (545,000 m³/d) of primary effluent during peak flows.

"The South Primary Effluent Conduit was 1050 linear ft [320 linear m] of reinforced, cast-in-place concrete that was exposed to hydrogen sulfide corrosion for almost 30 years," said Orin Padgett, the Metro project manager for what became the South Primary Effluent Conduit Rehabilitation Project.

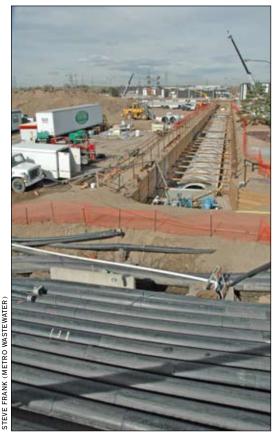
Last year, the Metro Wastewater Reclamation District (Denver) rehabilitated more than 1000 ft (305 m) of a reinforced concrete conduit with fiberglass-reinforced pipe. The project also required a 50-mgd (189,000-m³/d) bypass operation.
