Sewer Lateral Line Repair Challenges & Solutions

March 15, 2018

Challenges and solutions in removing I/I originating in sewer service laterals and at their connections to mainline sewer

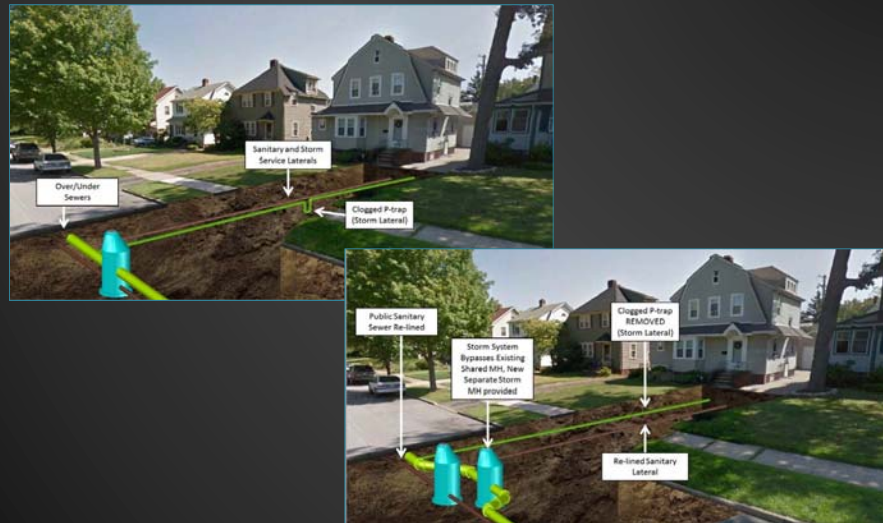
Lakewood Pilot Site

- Controlled area
- 102 structures (of 17,700 citywide)
- All houses flow into a single point
- Very good data of current state
 - Dry weather and wet weather
 - Allows measurement before and after
 - All houses in area were built in the same time period and are of similar design
 - Previously targeted in 1990s for removal of storm from sanitary

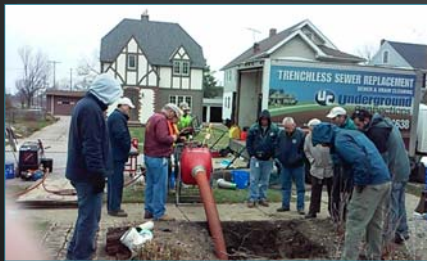
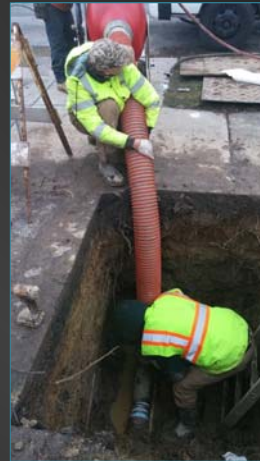
Lateral Lining - CIPP

- CCTV assure no footing drain before lining
- Remove roots or obstructions
- Lined laterals to eliminate infiltration

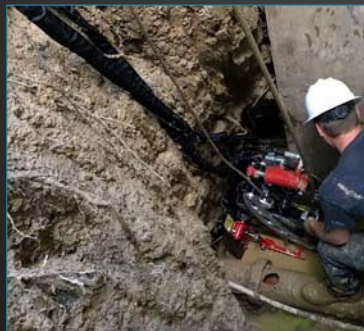
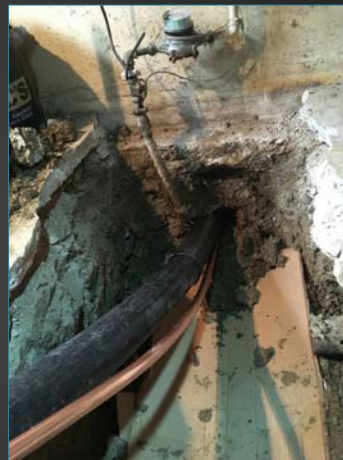
Lateral Replacement - Pipe Bursting

- Broken / collapsed pipe
- Replaced with HDPE

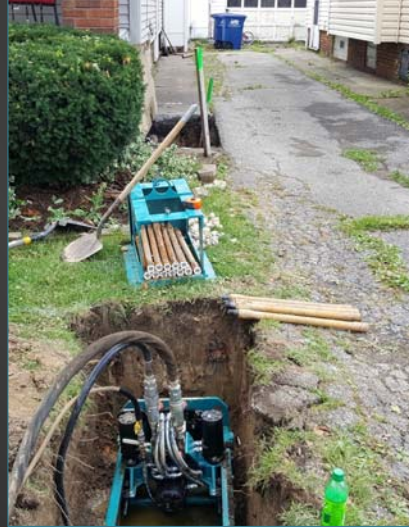
Drains and Downspouts - HDD

- Found all storm laterals had traps
- Rerouting of drain or downspout under driveway or sensitive areas
- Utilized directional drilling to minimize disruption and restoration costs

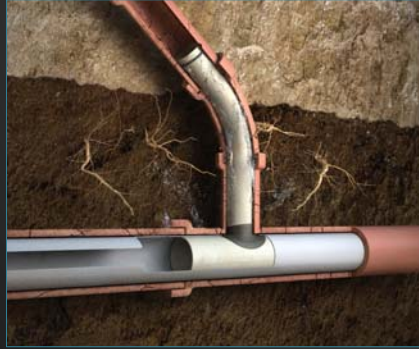
Purpose of Lateral Lining

- Seal annular space and connection between service lateral and CIPP lined mainline sewer
- Rehabilitate service lateral pipe to various lengths
- Increases life of critical component of the collection system

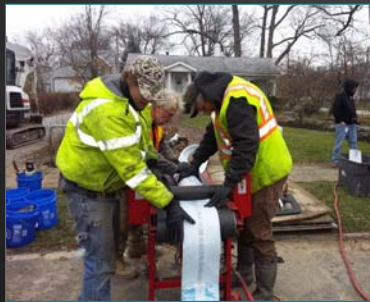
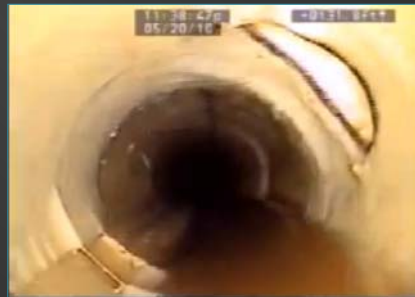
Key Component Lateral Rehabilitation

- Lateral connection seal
- Full length lateral lining

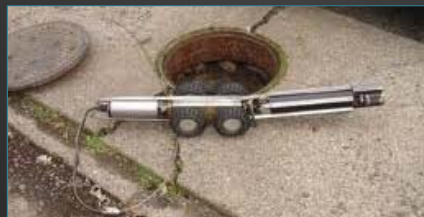
Inspection - Pan & Tilt

- Mainline sewer CCTV camera with pan & tilt
- Inspection performed from mainline sewer
- No cleanout/access point needed
- Can typically only see up a few feet

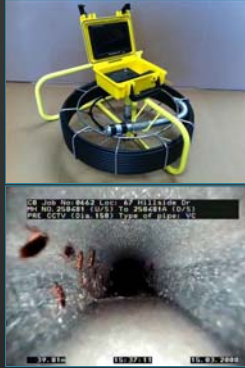
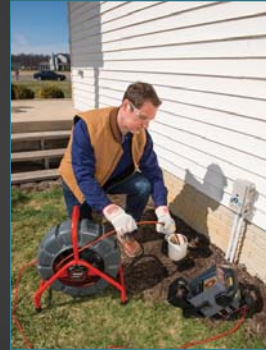
Inspection - Push

- Insert camera through cleanout or other access point
- Distance up to 150 ft

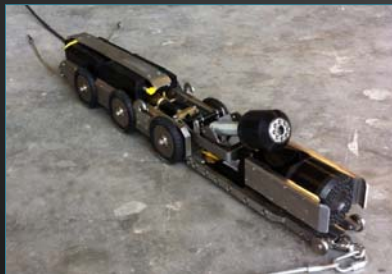
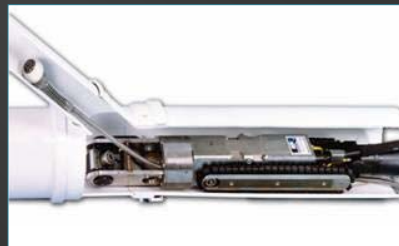
Inspection - Lateral Launch

- Launch camera from the mainline sewer
- No cleanout/access point needed
- Can traverse 80+ feet

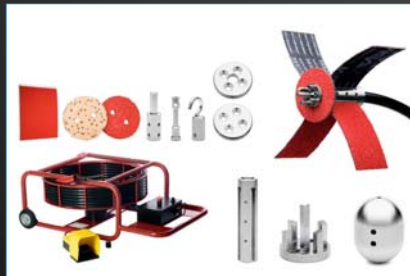
Lateral Cleaning

- Lateral cleaning techniques have improved
- Up to 80+ feet from mainline sewer
- Done with or without a cleanout/access point

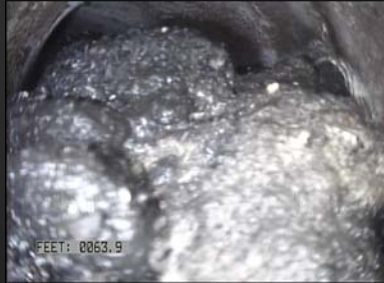
Pre-cleaning

Lateral Cleaning

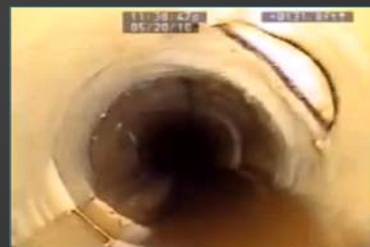
Lateral Connection Seal

- Rehabilitates lateral connection to mainline sewer
- Extends 24" - 36" into service lateral
- Installation performed from the mainline sewer
- Does not require cleanout/other access point
- Brim-Style or Full-Wrap in the main

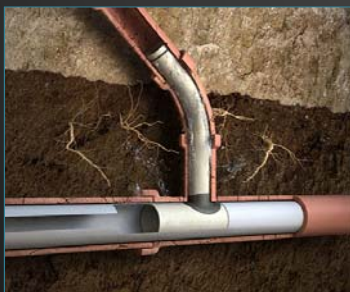
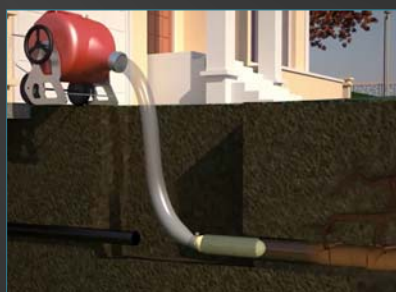
Full Length Lateral Lining

- Installed from mainline sewer or cleanout/other access point
- Extends various lengths and up to 4" cast iron from property
- Can seal connection to the mainline - installed from mainline
- Some products require a cleanout/other access point

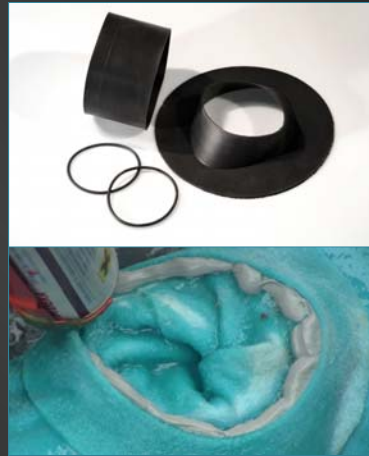
Installation and Sealing Properties

- Hydrophilic End Seals
 - Gasket
 - Paste
- Physical Bonding
 - Resin Migration
 - Epoxy Bond

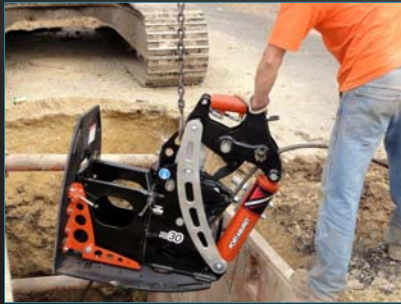
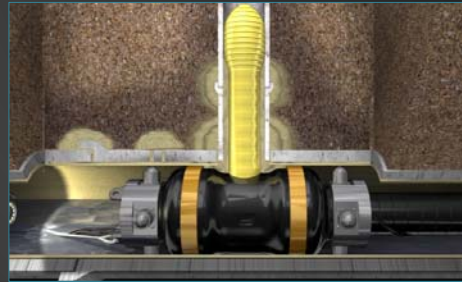
Additional Options for Lateral Rehab

- Grouting
- Pipe bursting

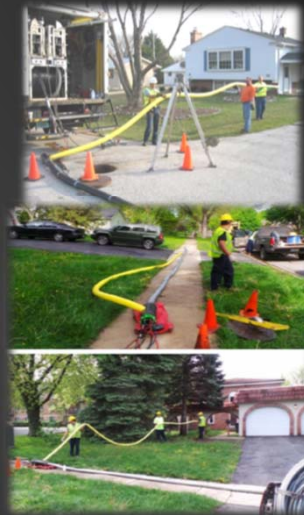
Lateral Tap Connection Grouting

- Mainline diameters from 6" -30"
- Effective sealing distances from 8" through 30 feet
- Diameter of laterals 4" , 5" or 6"

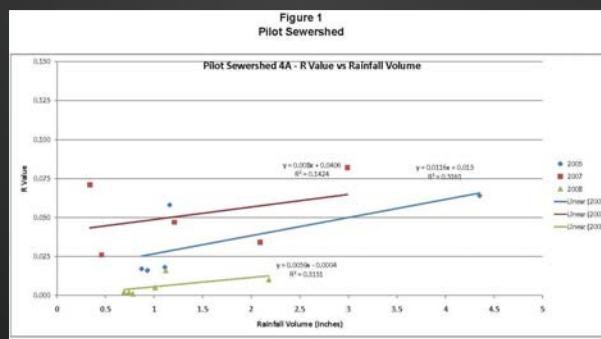
Verification of Flow Removed

- Re-meter study area and control area
- Analyze groundwater conditions pre- and post-construction
- Evaluate changes in control area
- Perform regression analysis
