# Innovative Internal Camera Inspection and Data Management for Effective Condition Assessment of Collection Systems

# **Innovative Internal Camera Inspection and Data Management for Effective Condition Assessment of Collection Systems**

Kathy Martel, P.E., and Mary Ellen Tuccillo, Ph.D.  
The Cadmus Group, Inc.

National Risk Management Research Laboratory  
Office of Research and Development  
U.S. Environmental Protection Agency  
Cincinnati, OH 45268

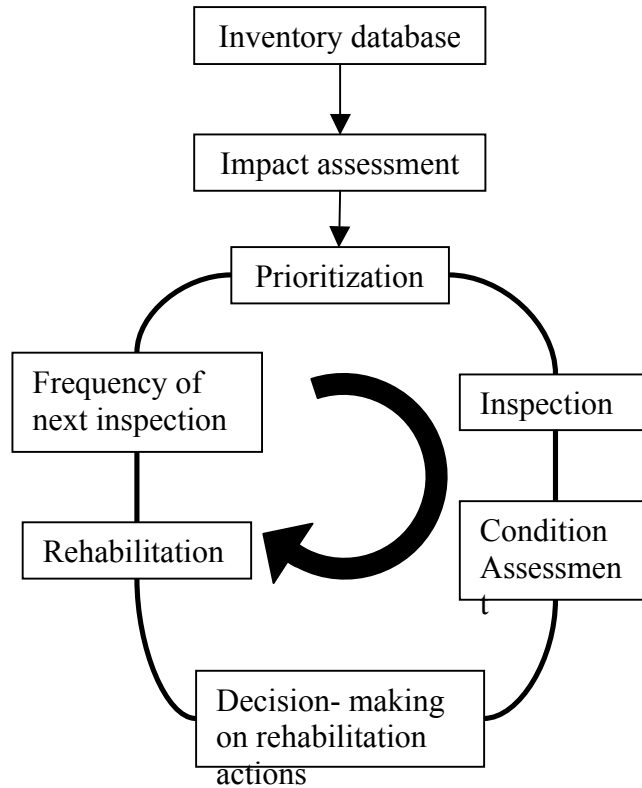
**Figure 1-1. Condition assessment steps. Source: McDonald and Zhao (2001).**

Figure 1-1 presents an approach for condition assessment that recognizes its iterative nature. In this example, the assets are first identified and an inventory database is established. Next, the impact assessment is conducted to inspect assets and determine their physical conditions. The next step involves setting priorities or rankings, from low to high priority, for different pipes in the system. This step helps the utility determine how often each pipe should be inspected and maintained. As the utility completes additional inspections and maintenance, the priority ranking changes and the utility focuses on the new highest priority pipe. The ever-changing or iterative nature of the condition assessment process justifies investments in asset inventory databases and data management software so that the highest quality information is used to make decisions on asset management.

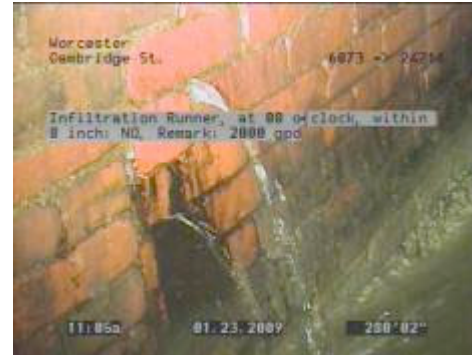
**Figure 2-2. Example of infiltration. Image courtesy of RedZone Robotics, Inc.**

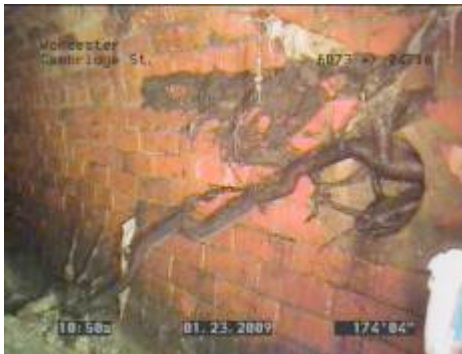
**Figure 2-3. CCTV image of roots in lateral. Image courtesy of RedZone Robotics, Inc.**

Figure 2-3 provides an example of a CCTV image that documents root intrusion. As noted above, CCTV technology has limitations because it can only provide a visual representation of the inside surface of a pipe above the waterline. Furthermore, the quality of defect identification and pipe condition assessment using CCTV is highly dependent on

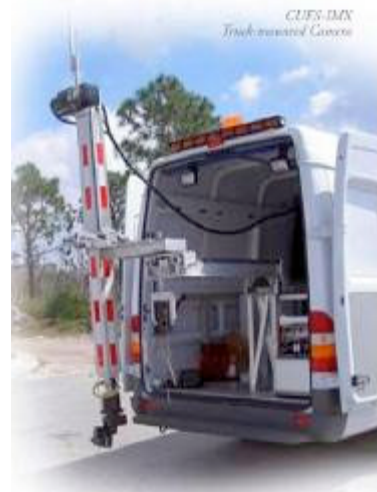
**Figure 2-5. CUES-IMX truck-mounted zoom camera. Source: CUES, Inc. (2009). Reprinted with permission.**

The CUES-IMX truck-mounted zoom camera (Figure 2-5) has a total effective zoom ratio of 300:1 including a 25:1 optical zoom range. The camera is stabilized and remotely controlled by a telescopic boom. It is equipped with high-intensity lights. The camera mounting fork is designed to pan the camera head 360° continuously, tilt mechanically 45° up or 90° down and tilt optically 166°. The camera system can be mounted within an inspection van, all-terrain vehicle or trailer. The camera housing is a damage-resistant, waterproof enclosure 7 in. in diameter and 16 in. in length. The CUES-IMX zoom camera system is equipped with data collection software, GIS software and global positioning system (GPS) equipment. The GIS software and GPS equipment are used to create sewer maps in the field and to create an asset management database for the system. Defects detected during the inspection can be stored in a database along with photos and video clips. All data are geo-referenced to the field-collected GPS coordinates. This is common in the industry and the subject of further discussion in Chapter 3.

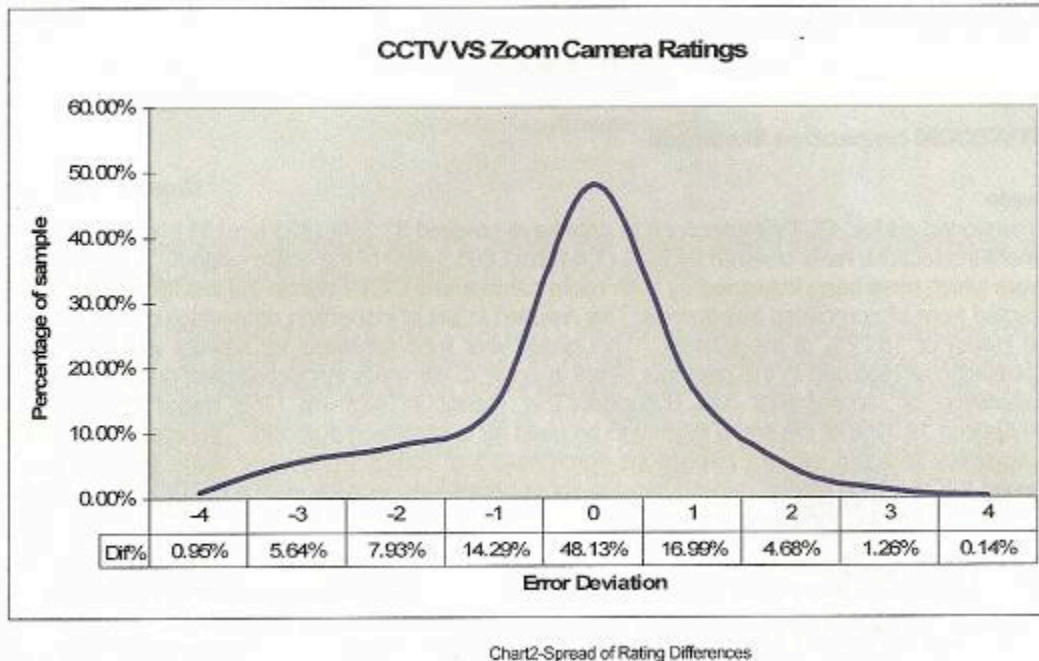
**Figure 2-8. Comparison of CCTV and zoom camera inspections.**  
**Source: Bainbridge and Krinas (2008). Reprinted with permission.**

Zoom camera accuracy compared to CCTV is an important criterion to consider. Utilities need to know how much accuracy will be sacrificed by using zoom camera technology for its expected savings in time and cost. The experience of one utility (Hamilton) provides a useful example. Hamilton compared the results of pipe inspections using both CCTV and zoom camera, as illustrated in Figure 2-8 (Bainbridge and Krinas, 2008). The graph compares how often the pipe condition ratings determined by CCTV and zoom camera inspection are the same (shown as 0 on the x-axis) or different up to four condition ratings (-4 and +4 on the x-axis). These results show that zoom camera and CCTV inspections resulted in the same condition rating approximately 48% of the time. Further, the two technologies differed by one condition rating about 31% of the time.

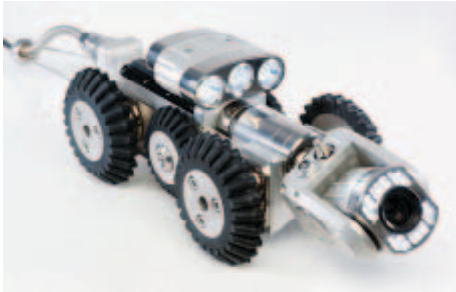
**Figure 2-13. Mobile robot inspection system.** Source: iPEK International GmbH (2009). Reprinted with permission.

In CCTV inspection, cameras are deployed into pipelines in a variety of ways. Mobile robots called crawlers or tractors (e.g., Figure 2-13) are available in a variety of sizes and configurations, enabling their use in various pipes sizes. These robots are typically introduced into the sewer via a manhole. Cameras can also be mounted on float rigs (Figure 2-14) for inspecting large-diameter pipes that are partially filled with water. Pushrod cameras are typically used in smaller diameter pipes (6 in. and less) such as service laterals and are typically introduced into the sewer through a cleanout.

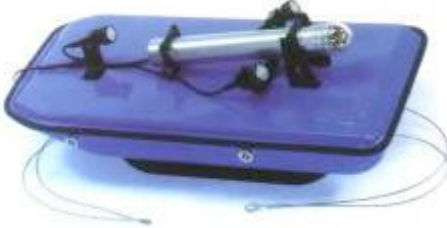
**Figure 2-14. CUES camera float.** Source: CUES, Inc. (2009). Reprinted with permission.

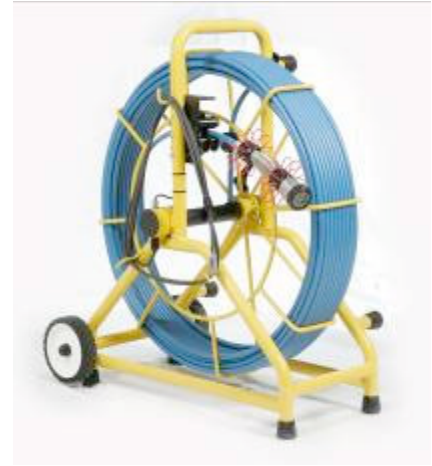
**Figure 2-15. Crystal Cam – push camera. Image courtesy of Inuktun Services, Ltd.**

Pushrod camera, or push cam, technology involves the inspection of pipelines with a small-diameter camera mounted to a pushrod and reel setup that provides video of the pipeline (e.g., Figure 2-15). This technology is primarily designed for laterals and small-diameter force main applications. Conventional push cams use straight view cameras capable of inspecting pipes 2-in. or more in diameter. Advancements include push cams capable of inspecting pipes smaller than 2-in. as well as steerable and pan/tilt push cams.

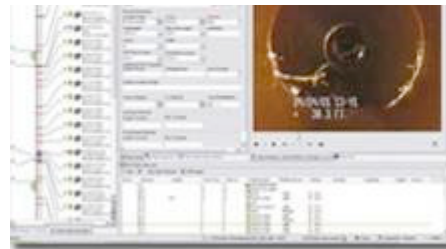
**Figure 3-1. Example CUES Granite XP pipe inspection map with camera image. Source: CUES, Inc. (2009). Reprinted with permission.**

(<http://www.epa.gov/cupss/>). Figure 3-1 is an example of a screen shot of a CUES Granite XP pipe inspection map and camera image. The publication “Implementing Asset Management: A Practical Guide” (AMWA et al., 2007) discusses some of the currently available software applications. Contact information for software vendors is provided in Appendix C.

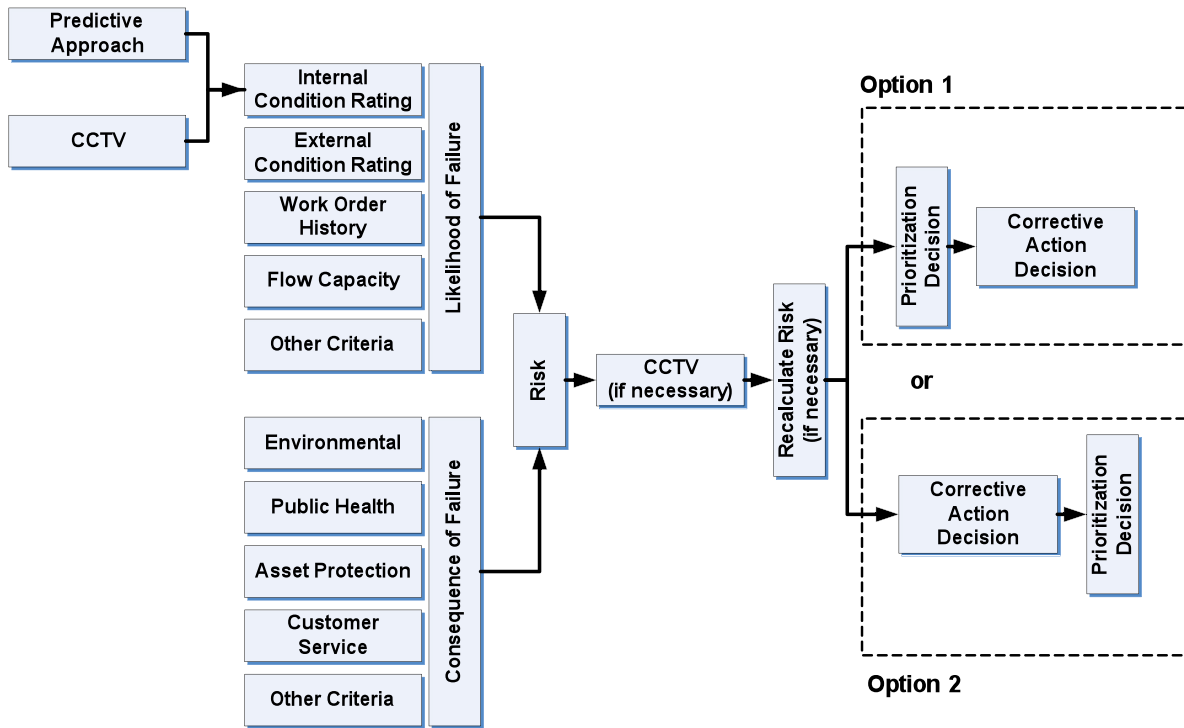
Figure 3-5. Example risk-based prioritization decision framework for multiple internal condition rating input sources.

Figure 3-5 presents an example of a risk-based approach to determine the priority assets for more comprehensive inspections or other corrective actions. The “Likelihood of Failure” and “Consequence of Failure” terms in the risk calculation are usually developed by constructing a matrix that lists the important criteria or service level factors and the associated score (AMWA et al. 2007). The “Likelihood of Failure” term considers both current internal condition information and time-based information (e.g., historical work order records). The “Consequence of Failure” term represents time-based information since it considers future events related to pipe failures. Figure 3-5 shows how CCTV data can be incorporated into the prioritization process. If the condition rating of an asset was initially determined by a predictive approach and the asset is then inspected using CCTV, its risk rating should be recalculated and its action reprioritized.

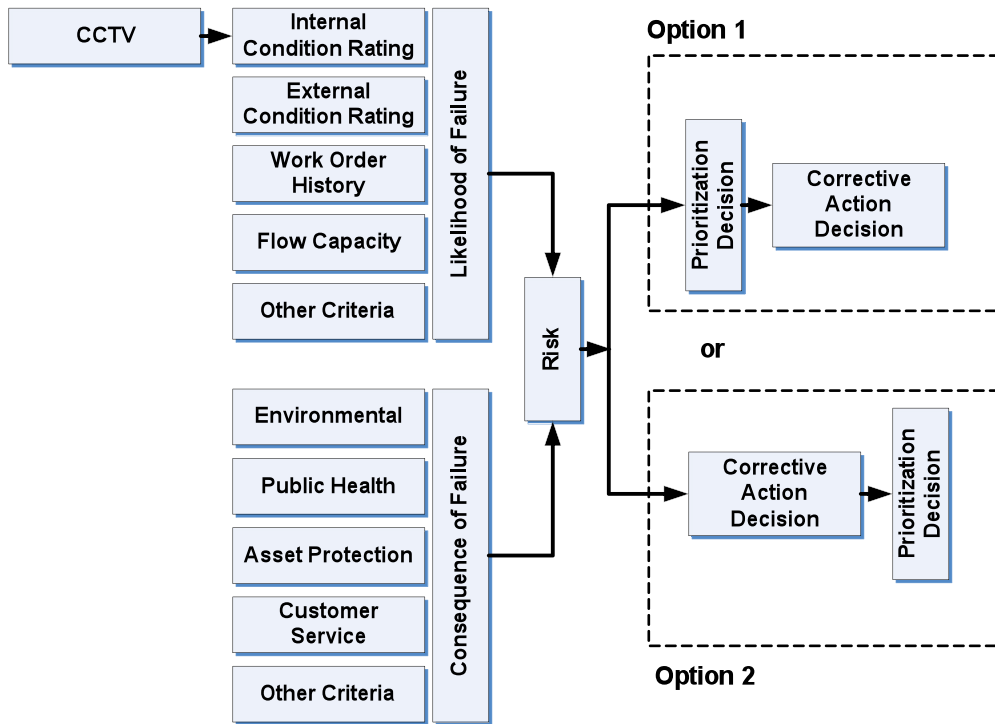
Figure 3-6. Example long-term risk-based prioritization decision framework.

Figure 3-6 is another example of a risk-based prioritization decision framework where the internal condition ratings are all based on CCTV data. Asset prioritization and corrective action Options 1 and 2 are the same as discussed above under Section 3.5.1, Condition-Based Prioritization Decisions.

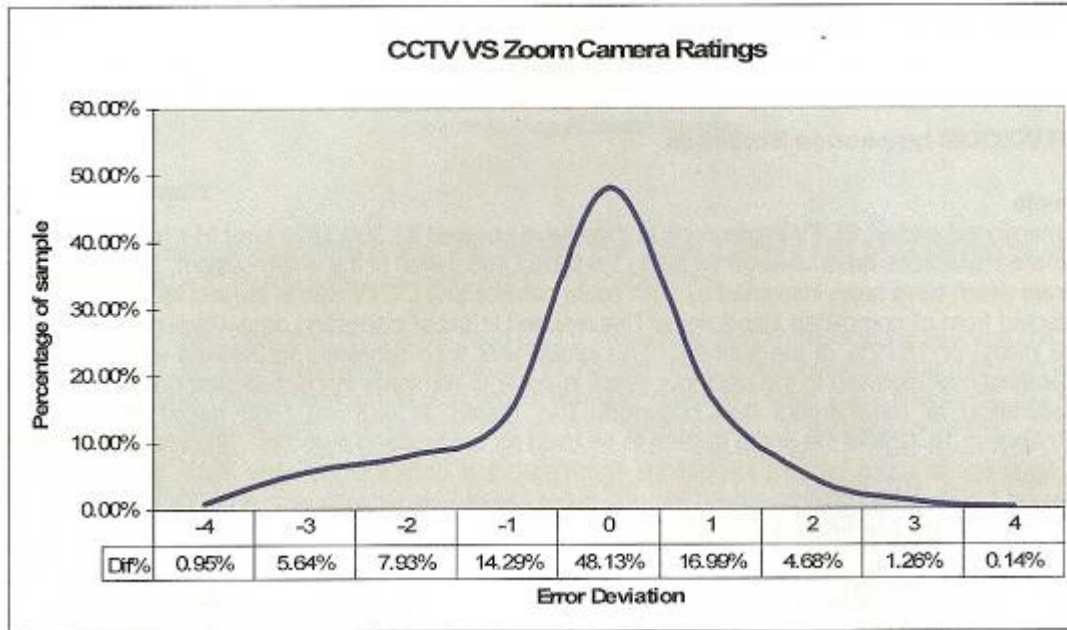
Figure A-5. Comparison of CCTV and zoom camera inspections.

Hamilton has been able to compare the results of inspections in pipes that have undergone both CCTV and zoom camera inspection. This analysis provides some understanding of how the two methods differ. Figure A-5 shows the results of a statistical analysis of condition ratings from CCTV and zoom camera inspections. It was found that zoom camera and CCTV inspections resulted in the same ratings (zero on the X axis in Figure A-5) approximately 48% of the time. The assessments differed by a condition rating of 1 about 31% of the time.

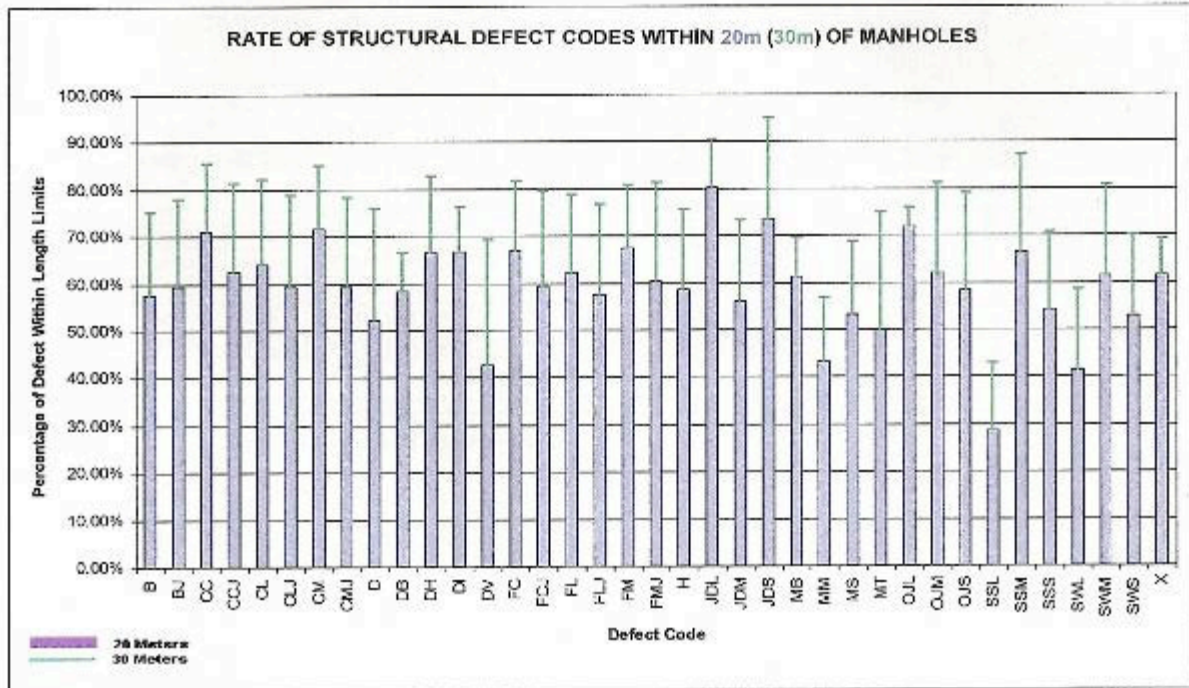
Figure A-6. Pipe defect location.

As another means to assess the accuracy of zoom camera technology, CCTV data were used as a basis to determine how many defects were located within the zoom camera's functional range. Figure A-6 (Bainbridge and Krinas, 2008) shows the percentages of defects located within 20 m (66 ft) (purple bars) and 30 m (98 ft) (green lines) of manholes. The x-axis indicates the defect type. About 59% of defects were found within 20 m (66 ft) of manholes and 76% were within 30 m (98 ft). This analysis provides some indication of the percentage of defects that are likely to be detected because of their proximity to the camera.

Bainbridge and Krinas' (2008) analysis suggests that zoom camera technology may not be as accurate as CCTV. However, Hamilton has found the level of accuracy sufficient for its sewer management strategy. Hamilton's zoom camera inspection program has resulted in more than 5,000 work orders and beneficial economic and social impacts.

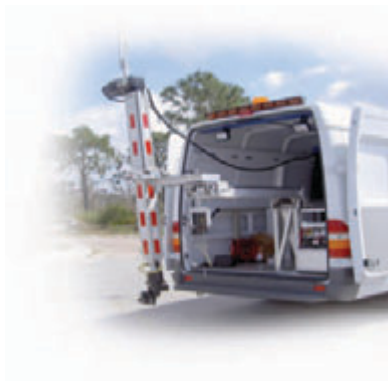
**Figure A-7. Truck-mounted zoom camera.**

The assessment portion of the project included inspection of gravity sewers with zoom camera and standard in-line CCTV inspection technology, where warranted, to collect physical attribute and condition data. The initial inspections were conducted using zoom camera technology from street level. Manholes and pipelines located within the right-of-way and within 400 ft of the right-of-way were inspected using truck-mounted zoom camera inspection equipment (see Figure A-7). Manholes and pipelines located more than 400 ft beyond the right-of-way were inspected using a tripod mounting for the zoom camera instead of the truck-mounted boom and mast.

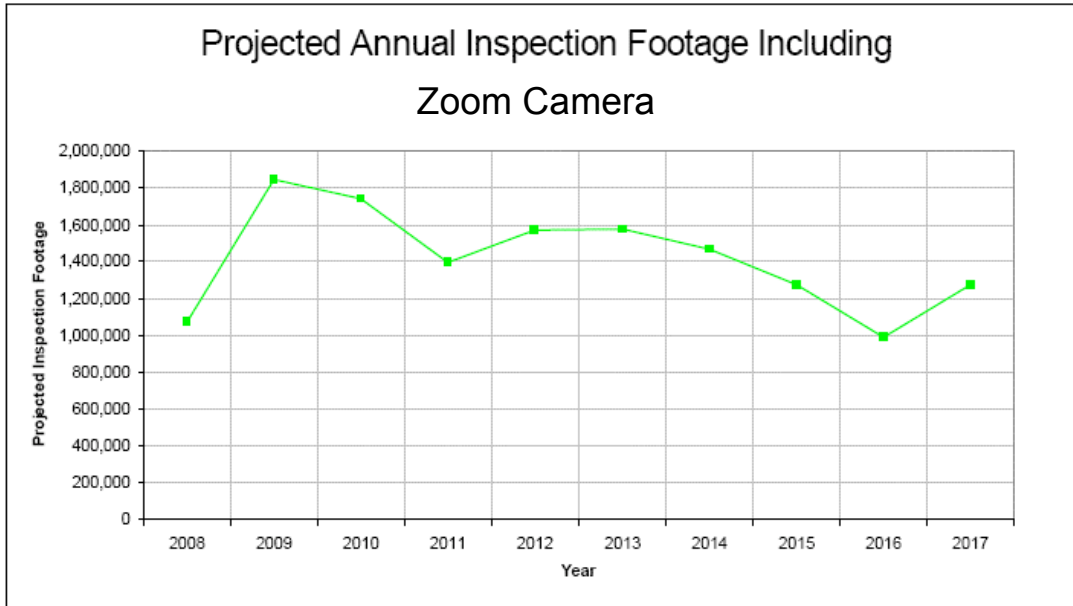
Figure A-11. Example District projection of the CCTV and zoom camera needs through 2017.

The lower priority sewers and newer sewers are inspected after year five of the program. The CSAP provides the data needed to focus cleaning, rehabilitation and replacement on the sewers with the greatest need. The re-inspection process informs cleaning or rehabilitation decisions, resulting in a more cost-effective program. This approach reduces the risk of service-related overflows compared to a linear inspection and cleaning approach (start at the top of the system and progress downward). An example projection of CCTV and zoom camera needs through the year 2017 is shown in Figure A-11 (2008 CMOM self-assessment report).
