SETTING SAIL ABOARD THE U.S.S. WWTP

Krista Johnston

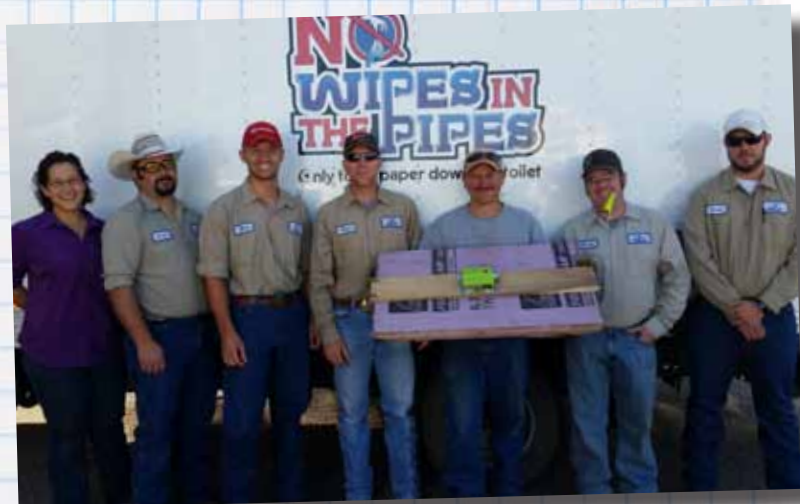
THE WASTEWATER COLLECTION CREW FROM THE CITY OF CASPER, WYO., SHOW OFF THE U.S.S. WWTP, WHICH THEY USED TO INSPECT THE PIPES BENEATH THE WATER RESOURCE RECOVERY FACILITY. PICTURED ARE KRISTA JOHNSTON, JARED WINZENRIED, MATT WILHELMS, DAVID FERGUSON, LANE CHRISTENSEN, BRODY ALLEN, AND JAMES SOLLER. City of Casper, Wyo.

When the City of Casper, Wyo., worried about the condition of the pipes within its 37,800-m³/d (10-mgd) water resource recovery facility (WRRF), the wastewater collection crew found a floating solution. The crew pieced together some foam-board, a piece of wood, rope, and some fasteners to create a raft for its collection system camera. They nicknamed the contraption the U.S.S. WWTP.

The wastewater collection crew knew that its collection systems camera could provide the information needed, the challenge was keeping it above the water's surface. So, they started fashioning a makeshift float. Using the materials at hand, the crew created a float for the camera – the U.S.S. WWTP.
